Manhole Inspection Summary

Manhole # S43EE_006MH

Location Address: **1040 BROADWAY AVE**

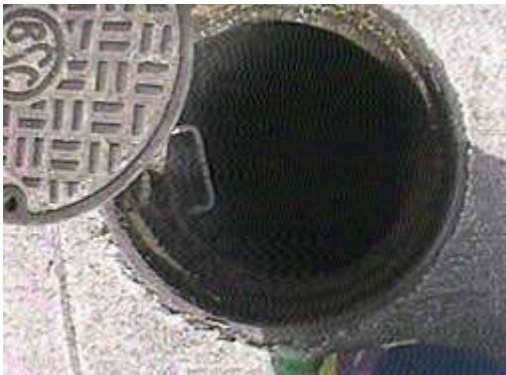
Defect 3

Condition: ☐ Sound ☐ Cracked ☐ Root Intrusion ☐ Deteriorated ☐ Leaks ☒ **Debris**

Count: **2** Missing: **2** ☒ **Corroded**

debris and corroded steps

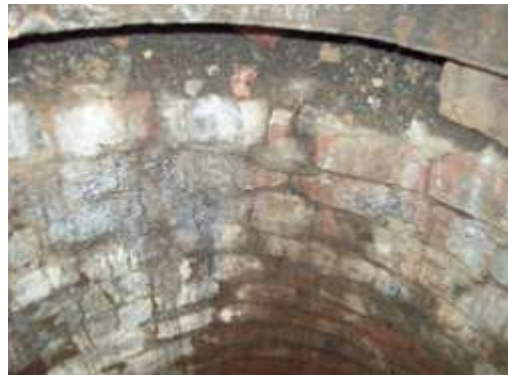
Defect 2

Offset: **1** (in.)

frame offset

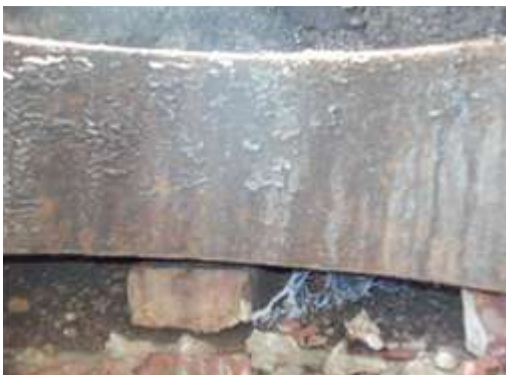
Defect 1

Condition: ☐ Sound ☒ **Cracked** ☐ Root Intrusion ☒ **Loose Brick** ☐ Deteriorated

Cracked chimney

Loose bricks

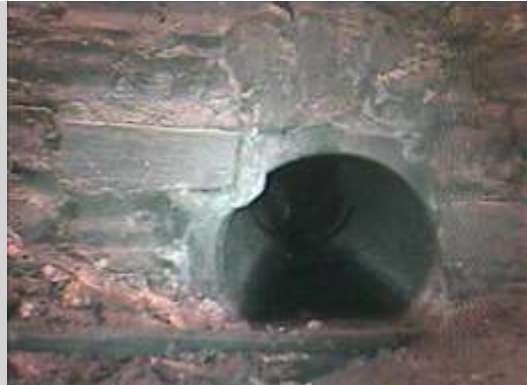
12 O'Clock Outflow

8 in. Circular Gravity Sewer
Pipe Out @ 12 O'Clock

Pipe Material: **Clay** ☐ Pipe Lined

Invert Depth: **8.51** (ft.) Flow Characteristics: **None**

Pipe Seal Cond: **Sound**
